Guest & Chrimes, Rotherham

Stewart Developments Ltd

Heritage Statement: Significance Appraisal & Impact Assessment

Heritage Statement – Issued: December 2024

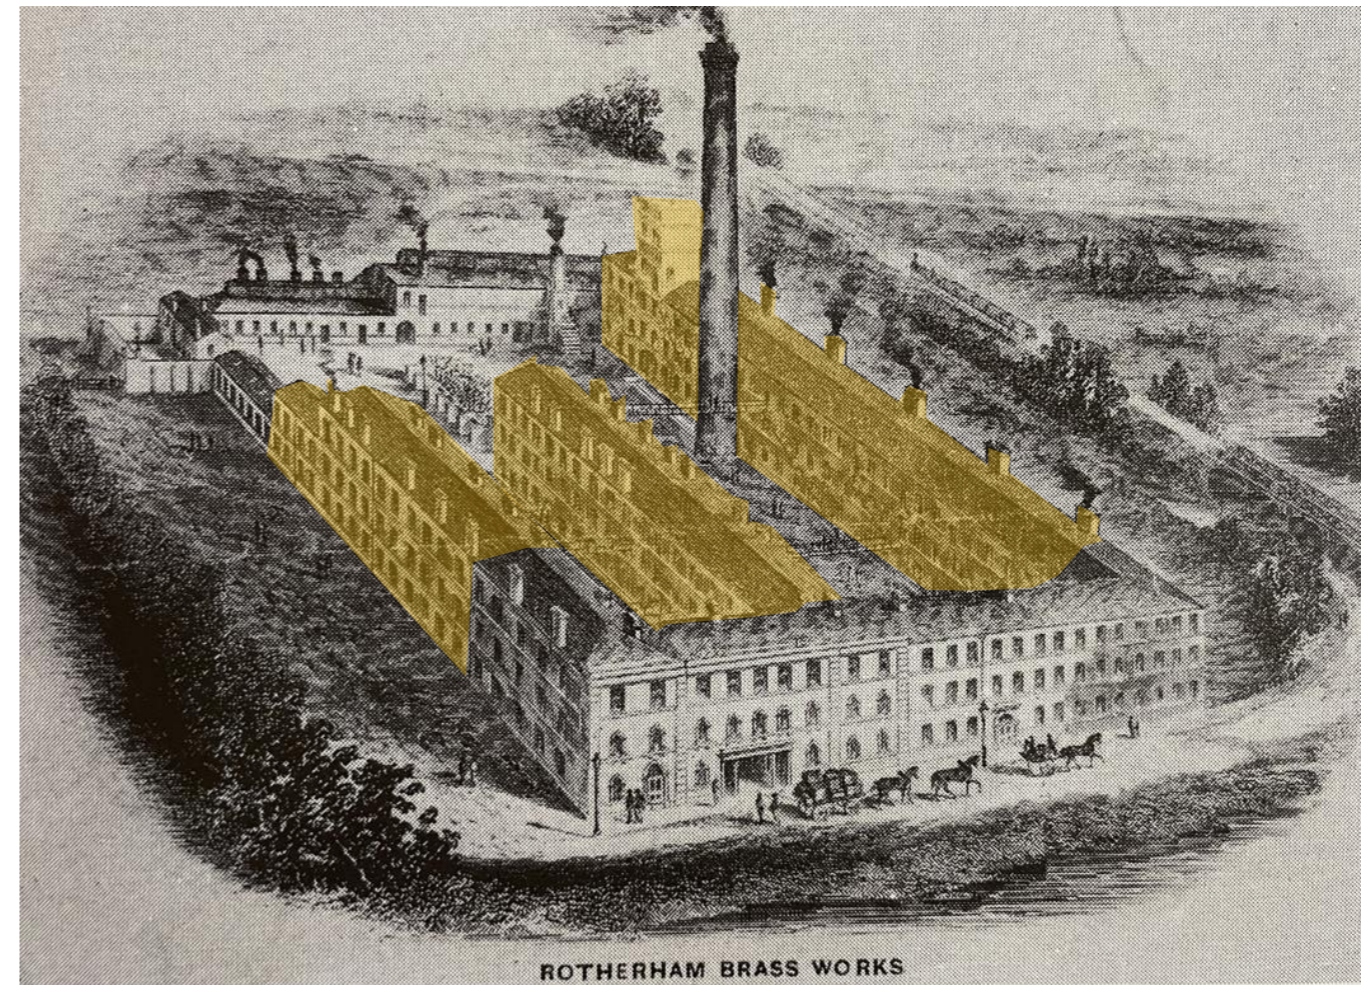
“An early, but undated birds-eye illustration of the new factory, probably drawn for a trade directory, shows a three-storey front office range facing the river to the east [captured in the photograph at **Figure 10**], with a two-bay caretaker’s house at its left-hand end and an angled return at its right-hand end continuing as a long, three-storey manufacturing range to the rear with a water tower towards its far end [Building 1]. The central yard is enclosed on the opposite, south side by a long range of single-storey buildings incorporating a two-storey, four-bay block approximately half way along [Building 3], and to the rear by one- and two-storey buildings with a number of wide stacks and a circular chimney in front towards the right-hand end. The yard also contains a very tall, circular chimney adjacent to the northern range with the water tower.”

Figure 9: Illustration of Guest and Chrimes, undated but assumed to be late 19th century. Approximate parts of the buildings which are surviving and within the Site highlighted in yellow. Source: Rotherham Archives and Local History.

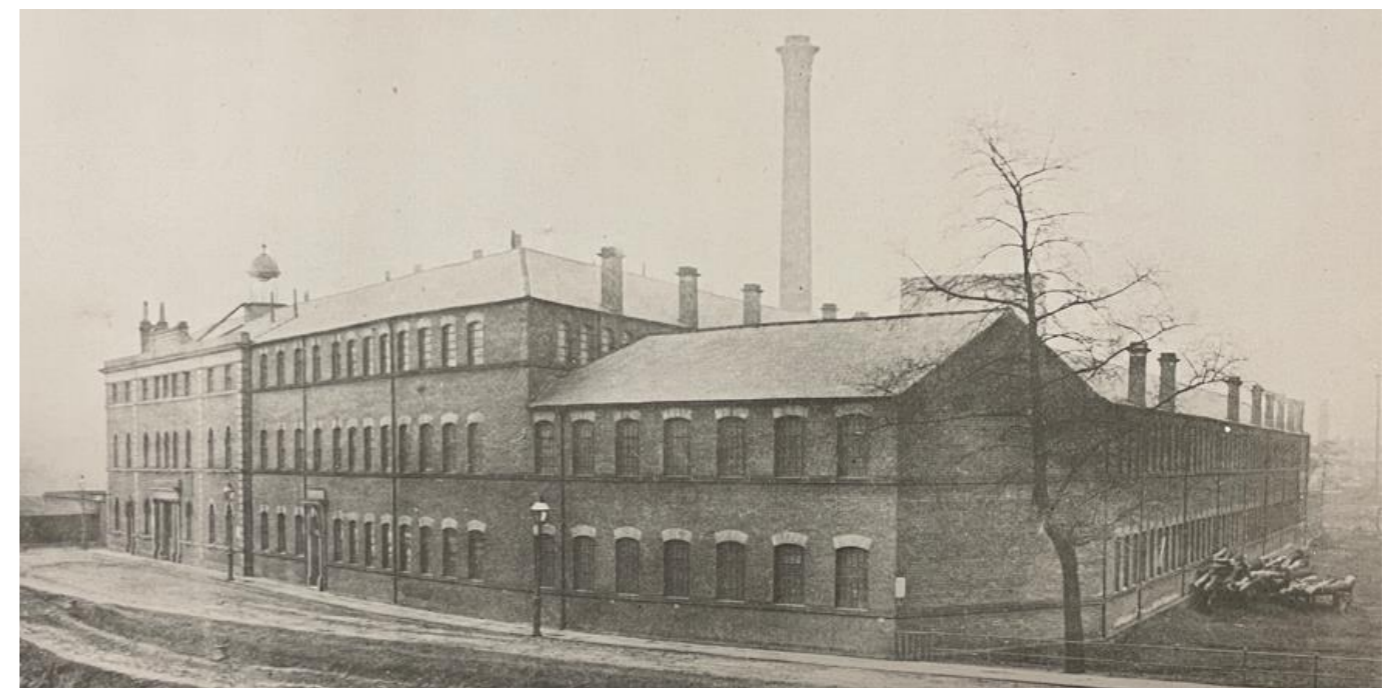
Figure 10: Guest and Chrimes former frontage to Don Street, c. 1897, since demolished. Source: Ellis Lanwarne, ‘A Sketch of the Life and Works of George Eskholme of Rotherham’, 1897, Rotherham Archives and Local History.

- vii) The office range provided the principal entry into the works, with the double width carriage passage clearly visible to the left-hand side of the photograph at **Figure 10**. Video footage records the end of a working day at Guest and Chrimes in 1901, showing workers leaving in large numbers through this entryway onto what is now Don Street¹. A photograph from a similar time at **Figure 11** illustrates workers in the central yard of the works.

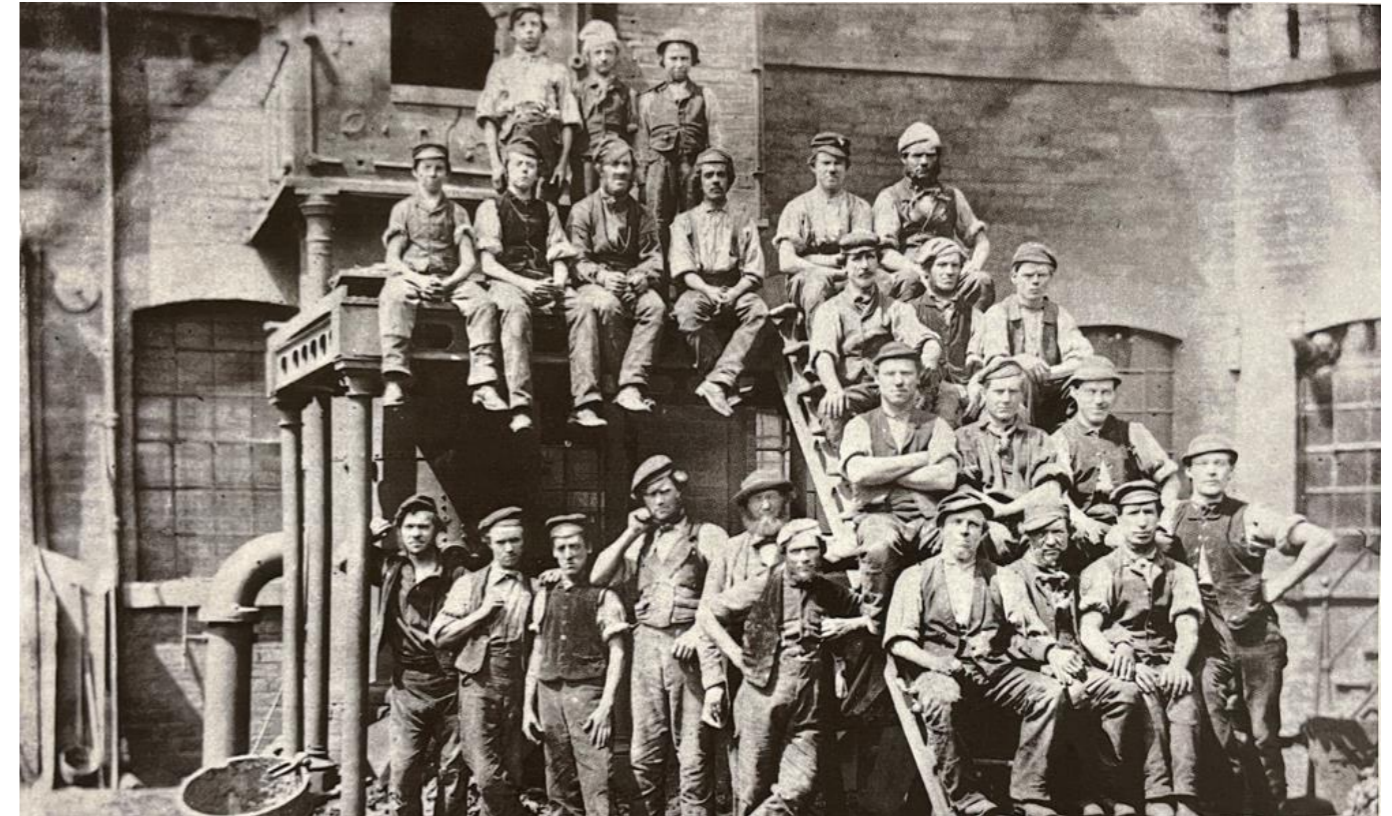
Figure 11: Workers at Guest and Chrimes. Undated but assumed to be late 19th or early 20th century. Source: Rotherham Archives and Local History.

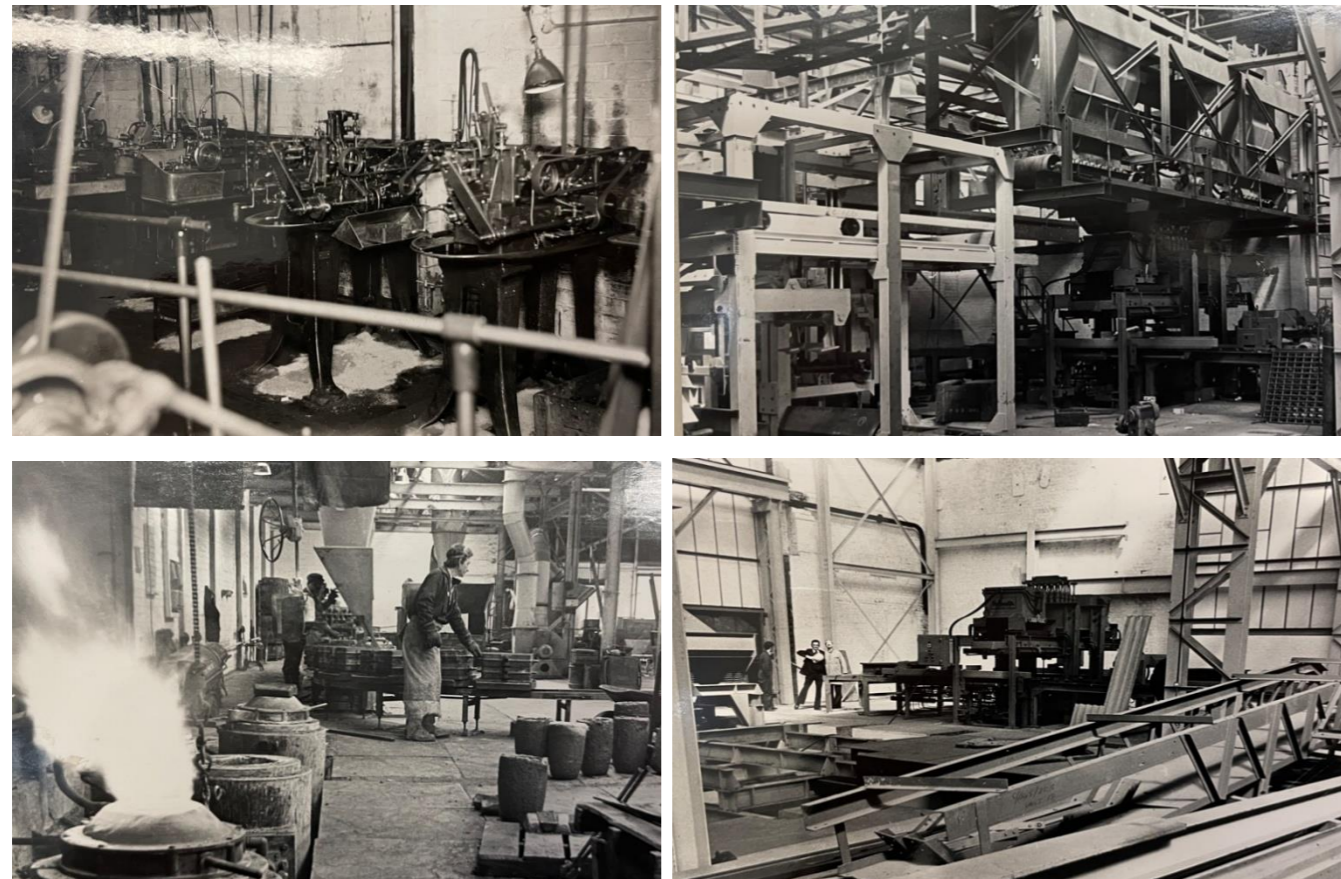
Figure 16: Brass Shop (top left) and Brass Foundry (bottom left), Iron Foundry (top and bottom right) at Guest and Chrimes, between 1920 and 1980. Source: Rotherham Archives and Local History.

- xv) **Figure 16** comprises a series of photographs illustrating the interior fixtures of the works and providing an insight into the practices in the 20th century. By 1961, it is recorded that Guest and Chrimes employed approximately 500 workers; by this point, they were using hydraulic engineers to produce sluice valves, water metres, penstocks and brasswork that was required for waterworks construction.

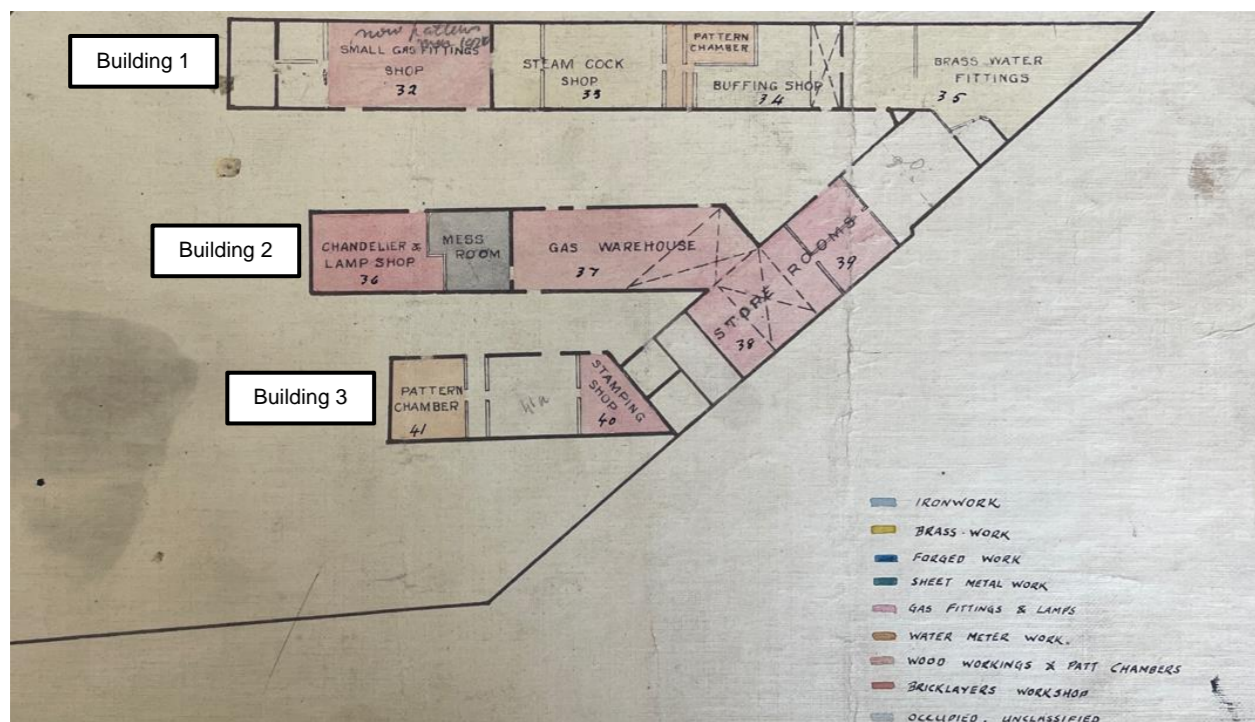
Figure 19 and 20: Undated plan first and second floor plans, assumed to be c.1900. Source: Rotherham Archives and Local History. Indicated uses at first floor as follows: Building 1 - pattern chamber, void, cock making shops, capstan lathe shop, Building 2 - pattern chamber, Building 3 - sheet metal workers. Indicated uses at second floor: Building 1 - small gas fittings shop, steam cock shop, pattern chamber, buffing shop, brass water fittings, Building 2 - chandelier shop & lamp shop, mess room, gas warehouse, Building 3 - pattern chamber, stamping shop.

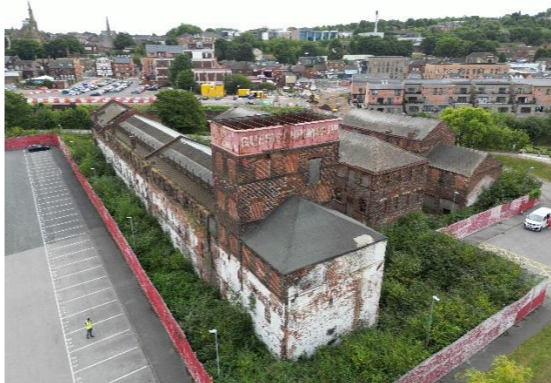
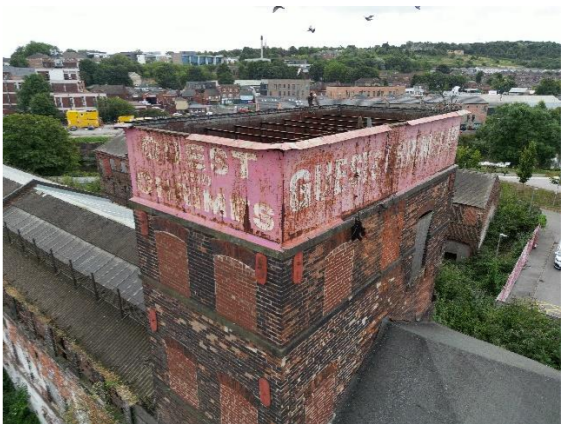
<p><i>Figure 24: Showing Building 1 in relation to Buildings 2 and 3. The building is surrounded by vegetation and inaccessible at the upper floors.</i></p>	<p><i>Figure 25: The water tank is supported by two storeys on top of the three-storey building. The tank is substantially rusted and corroded from water penetration.</i></p>

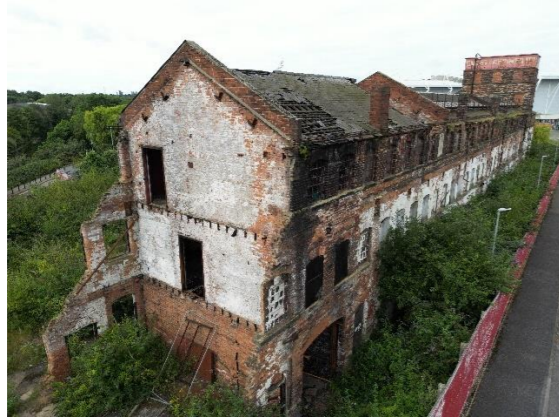
- vi) The building has significantly deteriorated at its east end following fire damage and the subsequent removal of the connecting wing. The cross wall has been exposed which has allowed water to penetrate the building.

Figure 26: The east end has substantially deteriorated following the demise of the connecting wing. The cross wall and its openings are open to the elements, permitting water into the building.

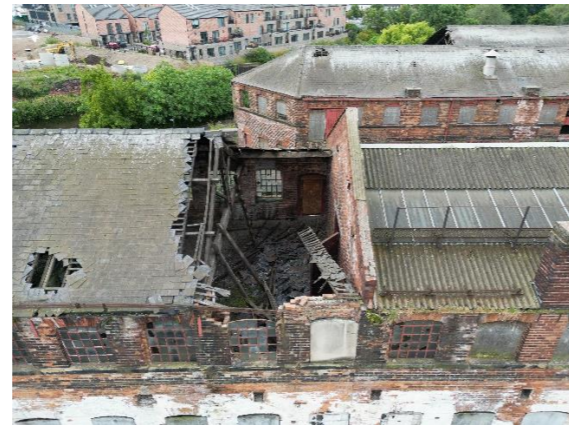
- vii) The roof has partially collapsed at the east causing localised structural failures in the lintels below. There is vegetation in the walls which has caused failures in the brickwork.

Figure 27: At the east the roof has collapsed exposing the timber trusses and floors to the elements. The building fabric is substantially damaged and decayed in this location.

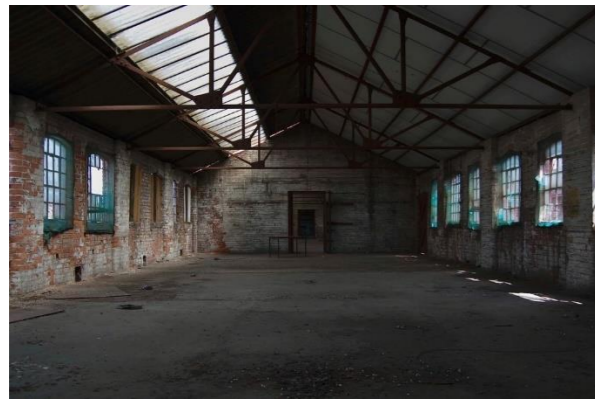
Figure 28: The third floor to the central bays shows the steel trusses and rooflight.

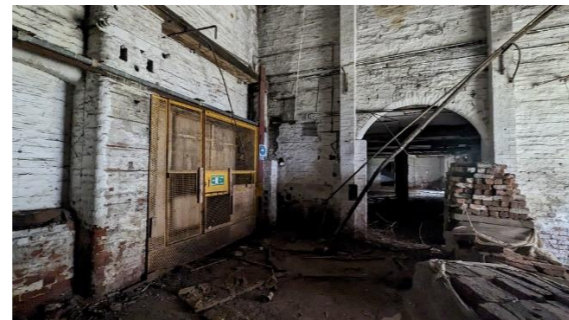
- v) Several window and doorway openings have been infilled at the ground floor and first floor levels. The building has been subject to modern modifications and repairs such as cement repointing of the facades and concrete blockwork walls.

Figure 29: At the ground floor several openings have been boarded up or infilled with brickwork.

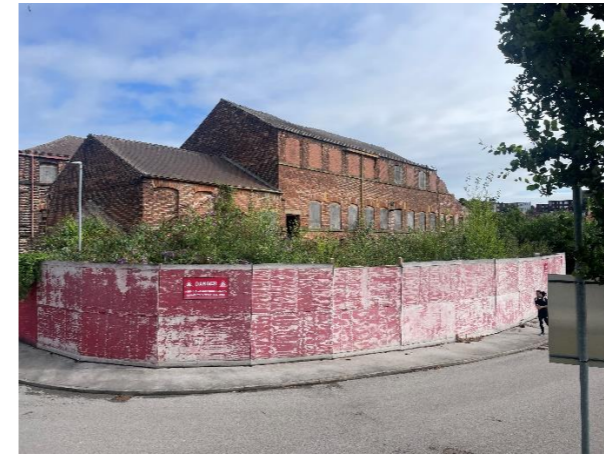
Figure 34: The south elevation of the building showing the two-storey and three-storey ranges.

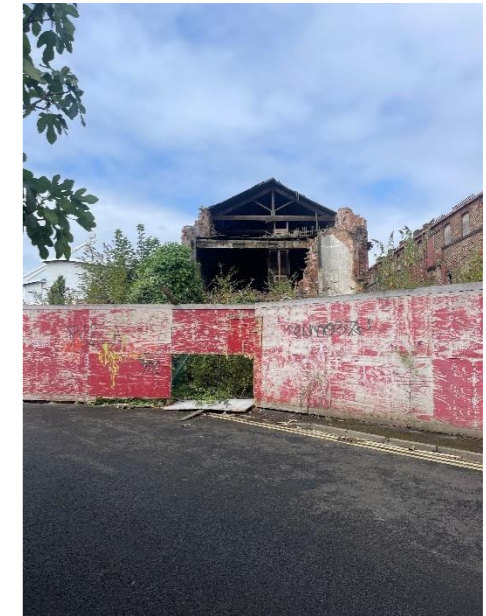
- v) The building has significantly deteriorated at its east end following the subsequent demolition of the connecting caretaker’s house. The east end of the building has collapsed at roof level to ground floor level. There is no external wall at the east end and internal structures are covered with debris from the collapsed roof, walls and timber floors and open to the elements, allowing substantial water penetration and subsequent decay to timber structures.

Figure 35: The east end of the building has totally collapsed, opening the east elevation up and allowing water to penetrate the structures, causing decay.

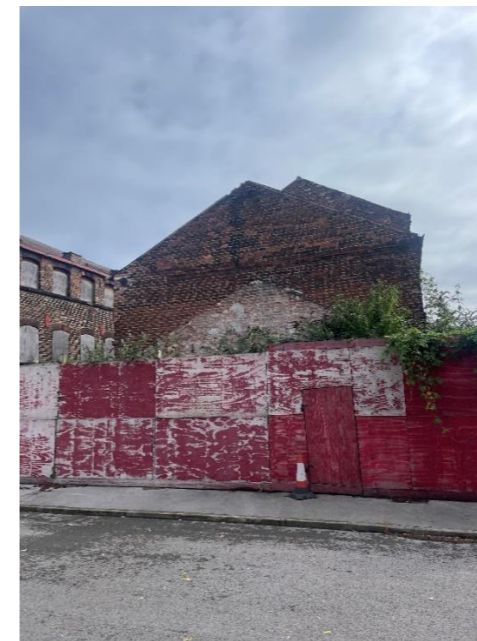
Figure 36: Note the outline of a single storey building to the west gable wall, the interior of the building previously painted white.

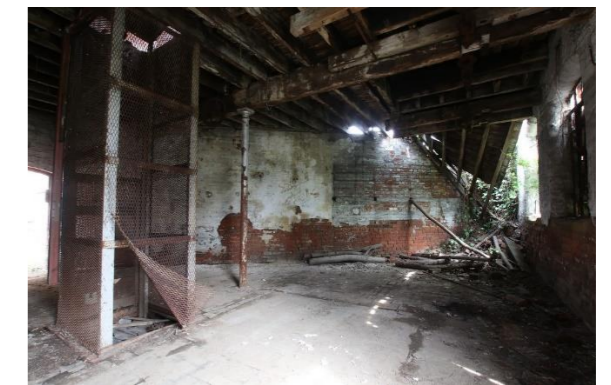
Figure 37: The east end of the building at ground floor level shows the collapse of from roof level. The first floor has decayed at the east and collapsed.

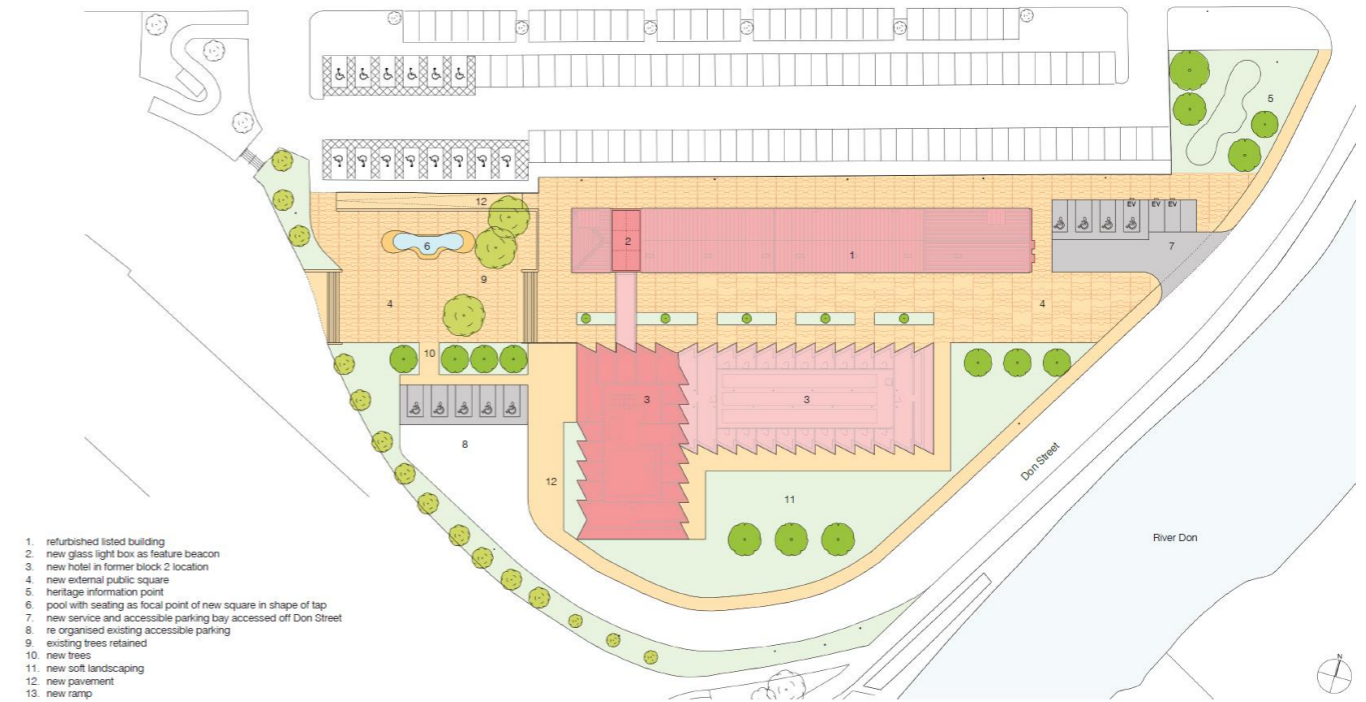
Figure 38: Proposed Development, including retained and extended northern block (Building 1) and new build element to the south within new landscaping scheme. Source: SHR Studio.

- ii) The proposed site arrangement and landscaping scheme is illustrated in the drawing prepared by SHR at **Figure 38**.
- iii) The architectural character of the Proposed Development has taken reference from the industrial heritage of the former brassworks, drawing on the materiality and forms associated with the Site. Connections to the Site's identity are manifested in the landscaping scheme, which includes architectural motifs associated with the leak-proof tap intrinsically associated with Guest and Chrimes and Rotherham and is carried through into the faceted form of the new building which draws on the geometry of a tap thread and resembles north-light roofs typically associated with industrial typologies.

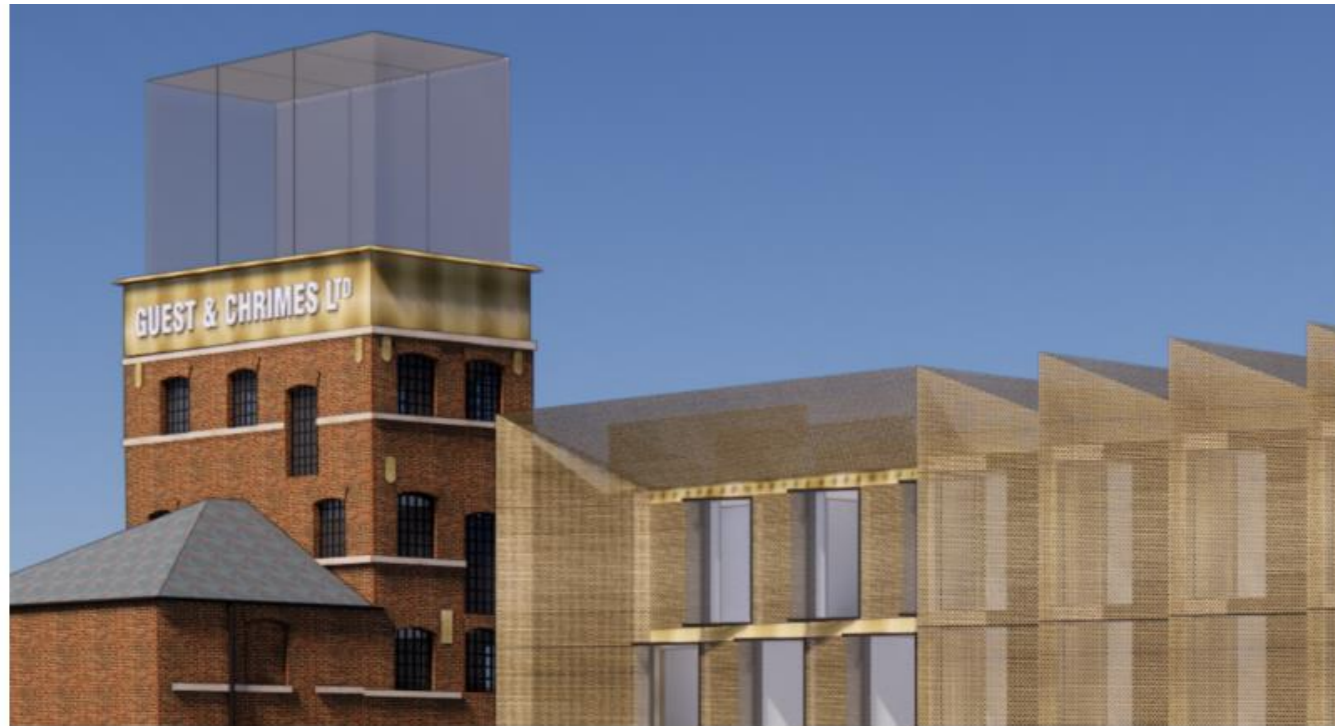
Figure 40: CGI illustrating relationship between retained northern block (Building 1) and new build element. Source: SHR Studio.

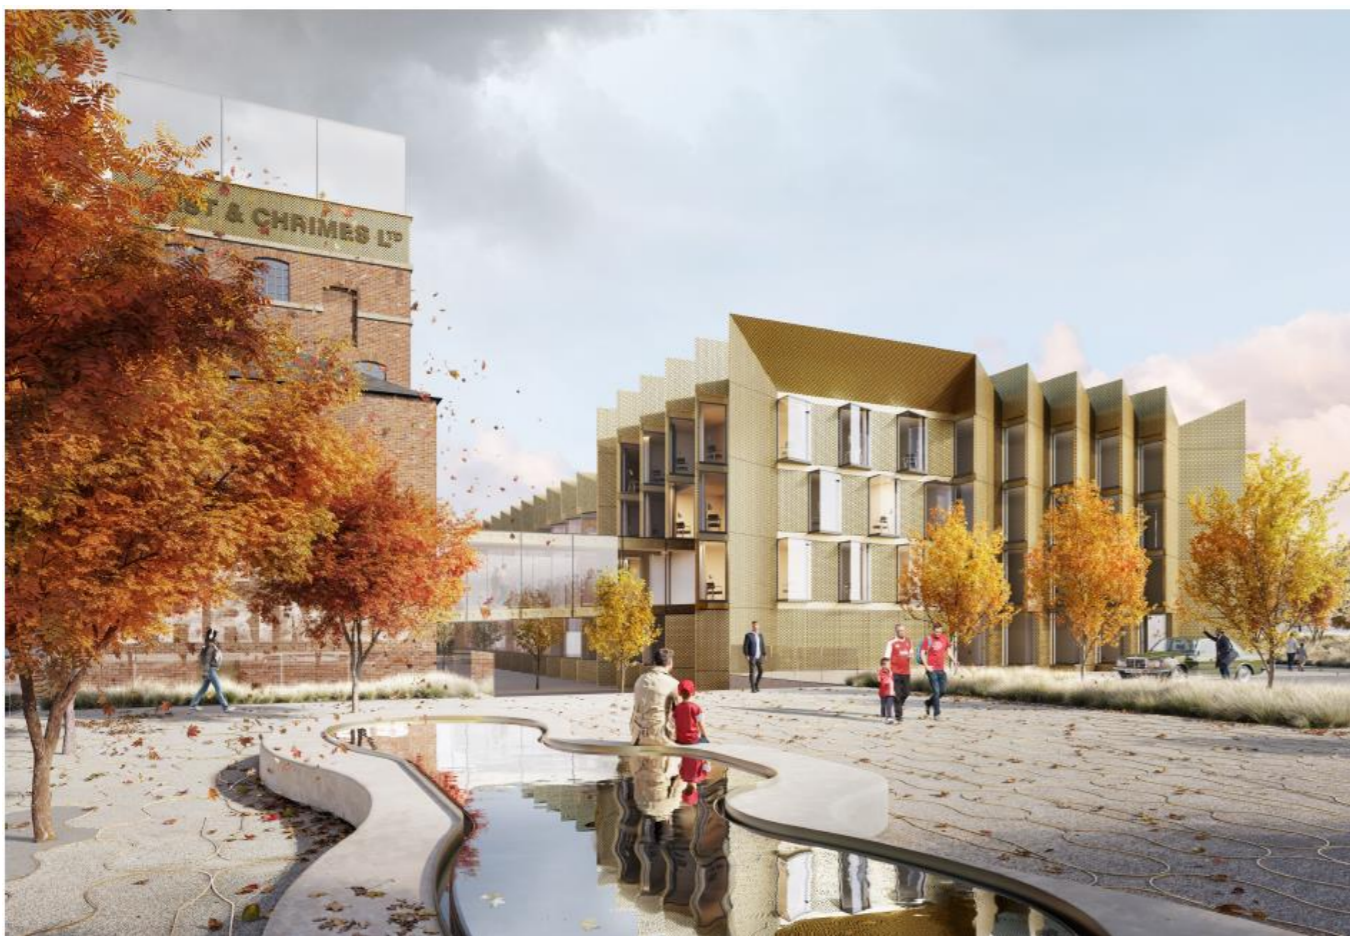
Figure 41: CGI illustrating the relationship between retained northern block (Building 1) and new build element and accompanying landscaping/public realm. Source: SHR Studio.

across Rotherham’s skyline. The feature will also act as a wayfinding device for the Site, drawing people towards it. Likewise, the raised glass link (see Figure 41) which will connect the historic building with the new accommodation block provides a clear and legible break between the two structures and makes reference to the elevated walkways which historically connected Buildings 1 and 2 across this yard.
